A Preliminary Characterization of the Tensile and Fatigue Behavior of Tungsten-Fiber/Waspaloy- Matrix Composite

Ralph E. Corner
Sverdrup Technology, Inc.
Lewis Research Center Group
Brook Park, Ohio

Brad A. Lerch
National Aeronautics and Space Administration
Lewis Research Center
Cleveland, Ohio

January 1992

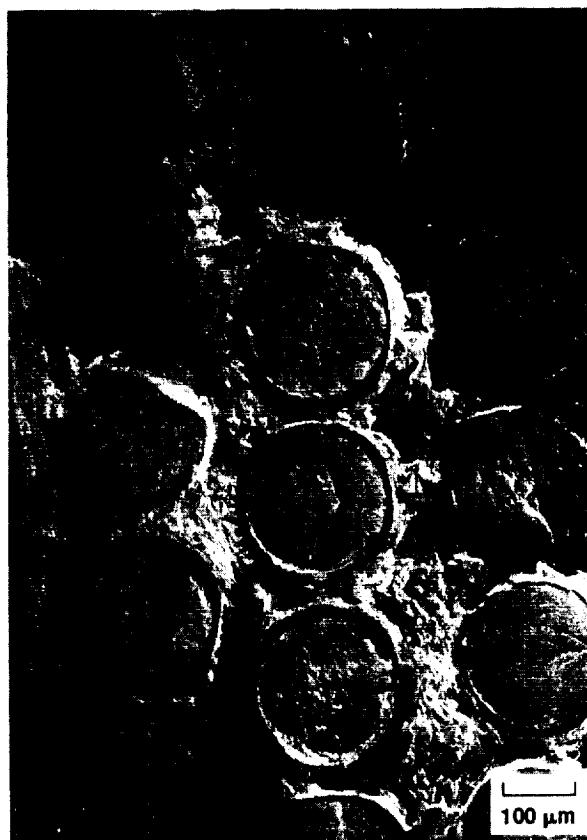
Figure 7.—SEM micrograph showing the fracture surface of tensile specimen.

SEM fractography of the failed tensile specimen (fig. 7), revealed a flat fracture surface. There was no evidence of fiber pull-out, indicating a good fiber/matrix interfacial bond. The matrix broke in a ductile fashion as indicated by the necking

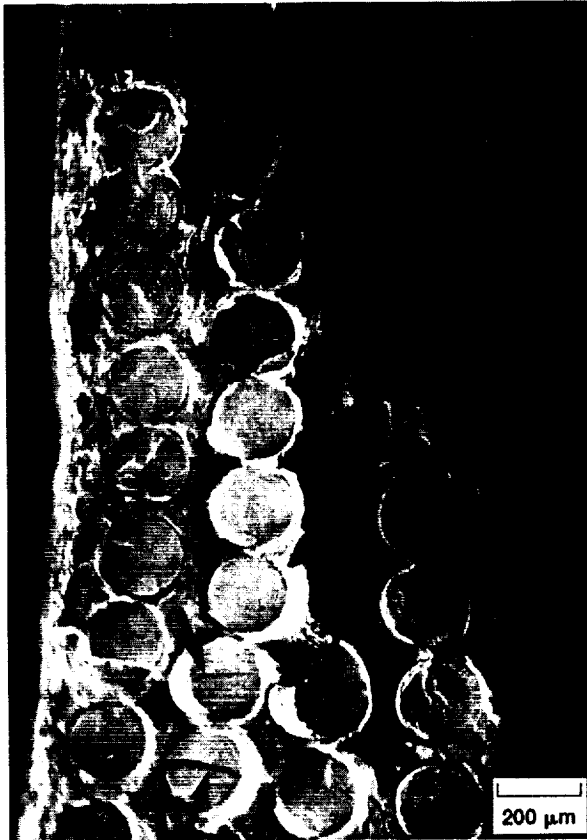
Figure 12.—SEM micrograph showing fracture surface of LCF specimen. Notice missing fibers in the third ply. Arrows indicate fiber splits.
